Repair Order #62707

2024 Nissan Altima SV  
VIN: 1N4BL4DV4RN430956  
Mileage In: 12,705 mi  
Mileage Out: 12,716 mi

Customer Comments	
Calibration from Radar and windshield camera

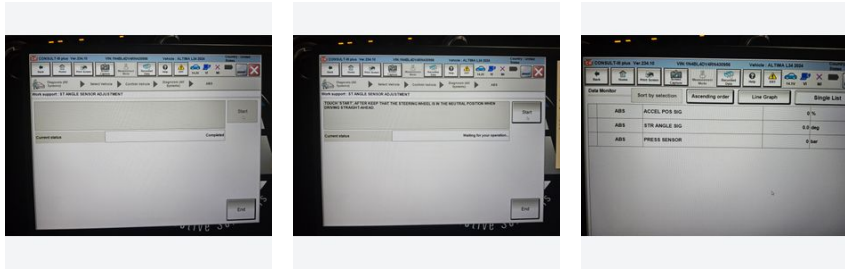
</div>				
4	STEERING ANGLE SENSOR ZERO/RESET CALIBRATION			✓
<p><b>Note/Recommendation:</b> ATTACH PICTURE OF COMPLETED SAS ZERO/RESET/CALIBRATION *****</p> <p><b>COMMENTS:</b> The Steering Angle Sensor (SAS) calibration was performed following the completion of the wheel alignment. The relearn/calibration process required the use diagnostic equipment. Accessing the vehicle's onboard computer system and enter the calibration mode for the steering angle sensor. This mode allows the reset of the sensor's reference point and establish a new baseline aligned with the updated wheel alignment settings. Successful completion of the steering angle sensor calibration procedure after the wheel alignment ensured that the ADAS systems and other systems that rely on it input would receive accurate steering angle information. This enabled the ADAS features and other systems, such as lane departure warning, adaptive cruise control, and electronic stability control, to operate effectively and make precise decisions based on the vehicle's movement.</p>

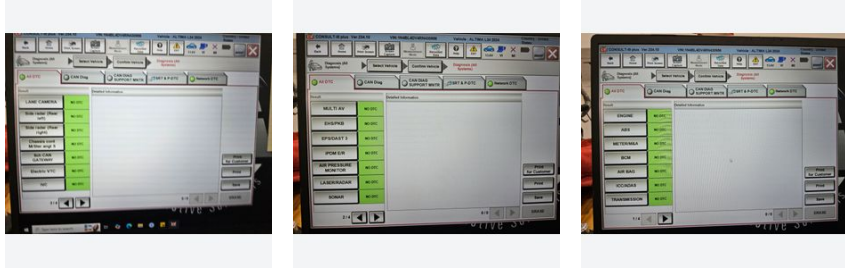
Item	Green	Yellow	Red	N/A
<p><b>Note/Recommendation: PIC DOC:FULL VEHICLE HEALTH SCAN</b>  *****</p> <p><b>SCAN TOOL USED: CONSULT 3</b></p> <p><b>TECH COMMENTS:</b> Scan Summary: A post scan of the vehicle, including the Advanced Driver Assistance Systems (ADAS), was conducted to assess its overall condition and identify any potential issues. The scan covered various key areas, including the engine and powertrain, electrical system, suspension and steering, braking system, safety systems, and ADAS components.</p> <p><b>Scan Results:</b></p> <ul style="list-style-type: none"> <li>• <b>Engine and Powertrain:</b> No significant issues were found during the scan. All engine and powertrain components are functioning properly. No codes active or stored.</li> <li>• <b>Electrical System:</b> The electrical system is in satisfactory condition. No noticeable faults or abnormalities were detected. No codes active or stored.</li> <li>• <b>Suspension and Steering:</b> Electronic suspension and steering components are in good working order. No codes active or stored.</li> <li>• <b>Braking System:</b> The braking system ABS, Traction Control is operating effectively. No codes active or stored.</li> <li>• <b>Safety Systems:</b> All safety systems, including airbags, seat belts, and restraints, are functioning correctly. They ensure occupant protection during accidents or sudden braking. No codes active or stored.</li> <li>• <b>ADAS Components:</b> The ADAS components, such as lane departure warning, adaptive cruise control, and forward collision warning, were inspected and have no codes active or stored.</li> </ul> <p><b>Conclusion:</b> Based on the post scan analysis, the vehicle, including its ADAS components, appears to be in good overall condition with no significant concerns or immediate repair needs.</p>
